Redstone Arsenal World War II Resource Study

Redstone Arsenal, Alabama

Contract Number DACW21-99-D0004

April 1, 2003

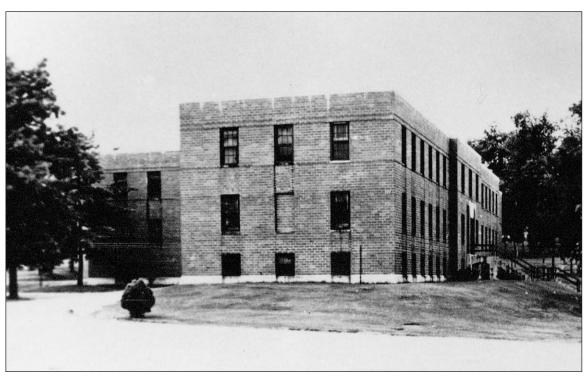
Figure 5 Building 111 Photographs

A. Historic photograph of administration building, Building 111 (AMCOM History Office).

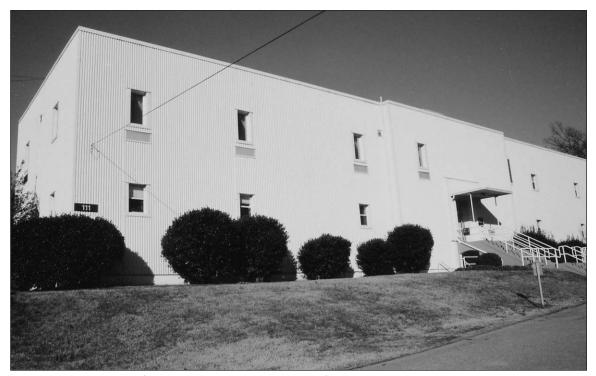
B. 1996 photograph of Building 111, south elevation from Cooper Drive (Panamerican Consultants, Inc., 1998).

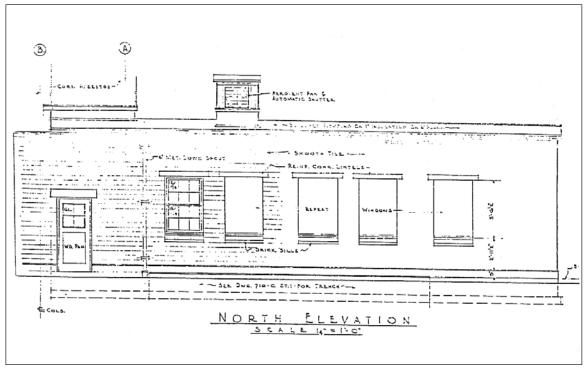
A. CI plant, detail of compressor building, Building 5562 (H. K. Ferguson 1943).

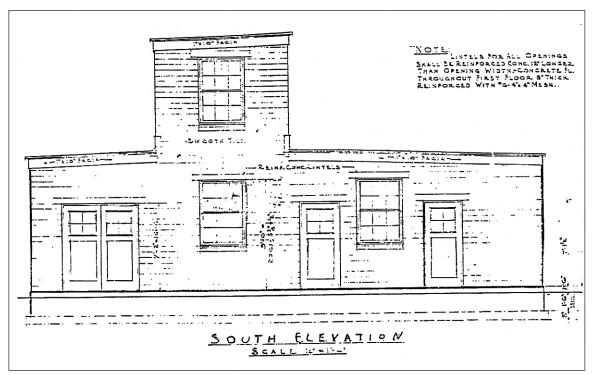
B. CI plant, detail of iron preparation building, Building 5566 (H. K. Ferguson 1943).

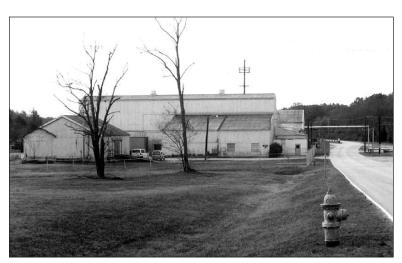
Mustard Gas Buildings Nos. 5671, 5672 and 5673.

The buildings in Plant Area 2 also still closely resemble the original structures. They were constructed of steel girders with roof and siding of corrugated APM, or asphalt protected metal—the same material which remains on all of these buildings except 5664, the tail gas scrubber building which has been re-sheathed with modern metal siding. The interiors are partitioned with hollow clay tile walls (*History of the Huntsville Arsenal* n.d.: 324). A few buildings like 5671 have small additions, but for the most part, the exteriors are unchanged. The hollow clay tile warehouses (5668, 5669, 5670) also remain unaltered (Figures 13 and 14). All of the buildings, however, have

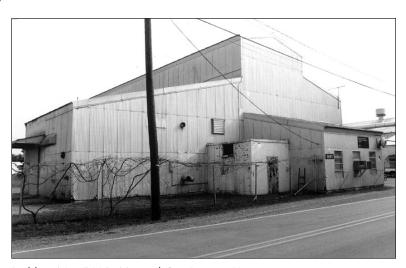
Building No. 5661, Mustard Gas Reactor Unit.

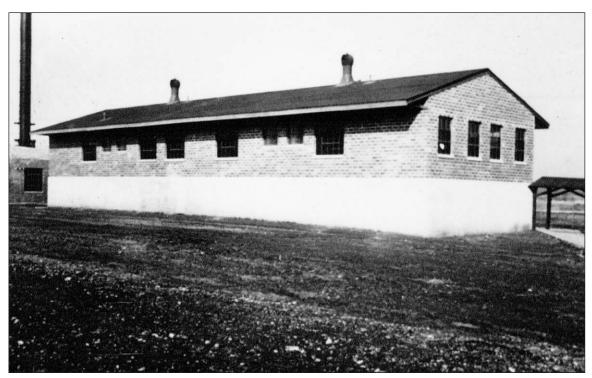
A. Historic photographs of change house, Building 7667, Redstone Arsenal (History of Redstone Ordance Plant ca. 1945).

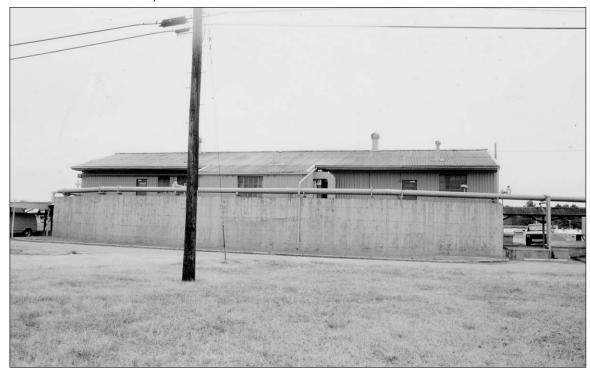
B. 1996 photograph of change house, Building 7667, Redstone Arsenal, Panamerican Consultants, Inc., 1998.

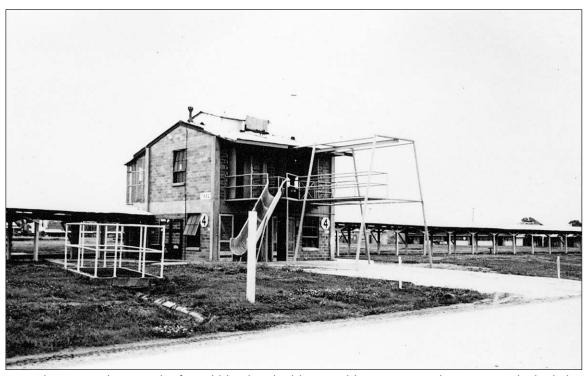
A. Early 1950s photograph of tetryl blending building, Building 7652, Redstone Arsenal (Thiokol Corporation ca. 1950).

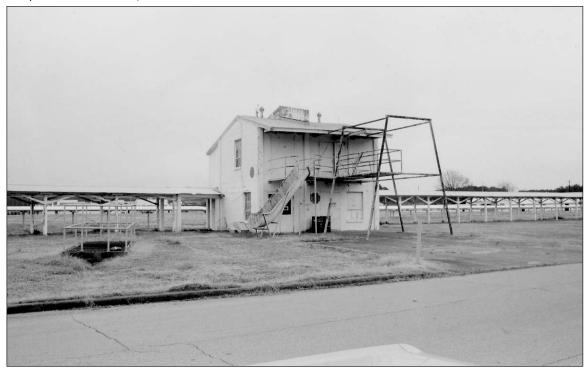
B. 1996 photograph of tetryl blending building, Building 7652 (Panamerican Consultants, Inc., 1998).

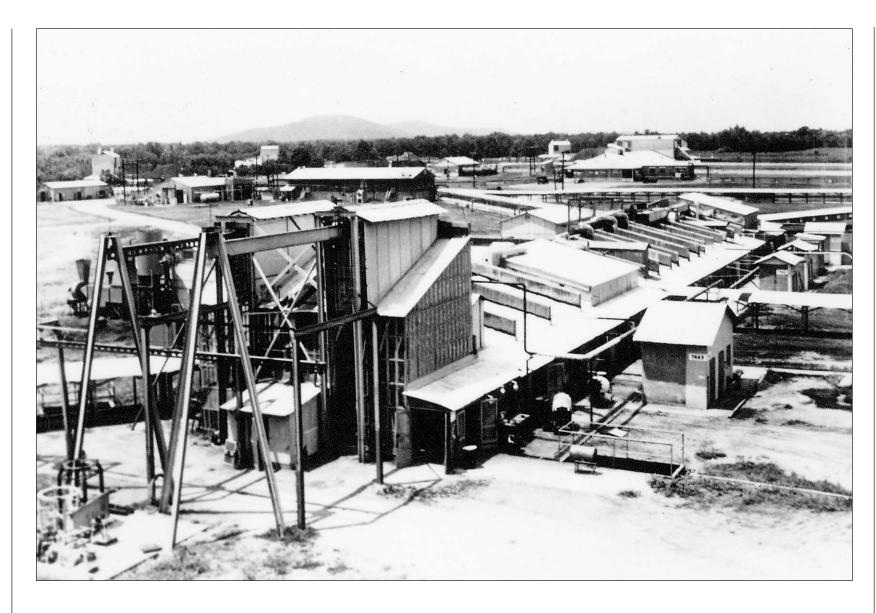
Figure 25 Photograph of Monorail and Crane System between Buildings 7662 and 7663, Redstone Arsenal

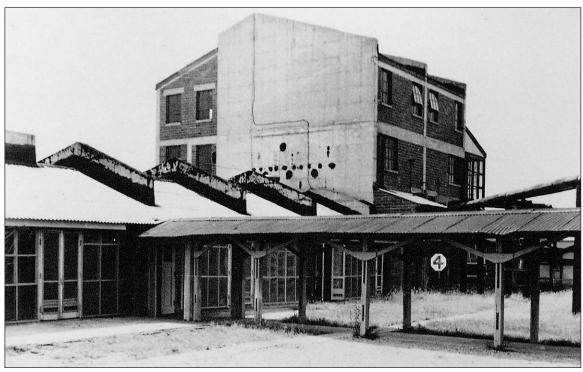
A. Early 1950s photograph of melt and pour building, Building 7726, Line 2, Redstone Arsenal (Thiokol Corporation ca. 1950).

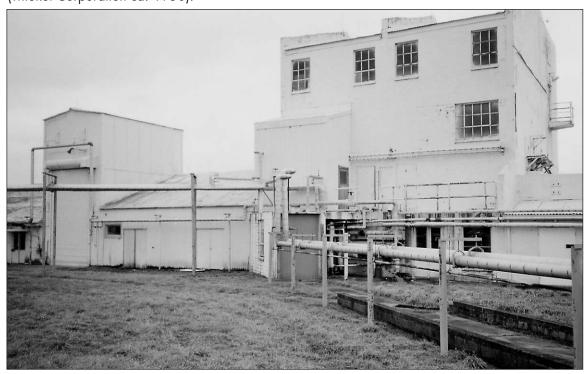
B. 1996 photograph of melt and pour building, Building 7726, Line 2, Redstone Arsenal (Panamerican Consultants, Inc., 1998).

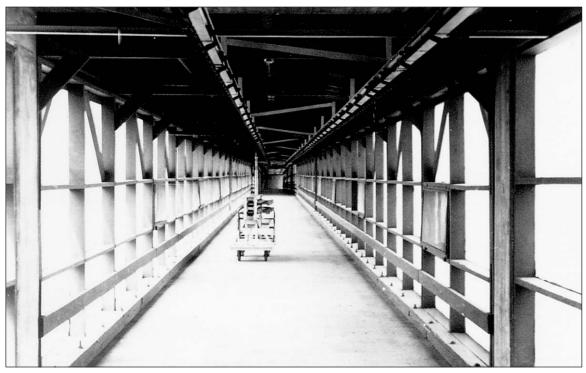
A. Early photograph of monorail system in covered ramp, Redstone Arsenal (History of Redstone Ordnance Plant ca. 1945).

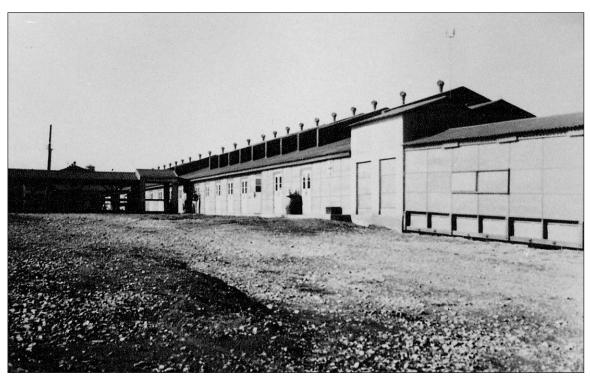
A. Early photograph of packing and shipping building, Building 7554, showing Cel-O-Glas additions, Line 3, Redstone Arsenal (History of Redstone Ordnance Plant ca. 1945).

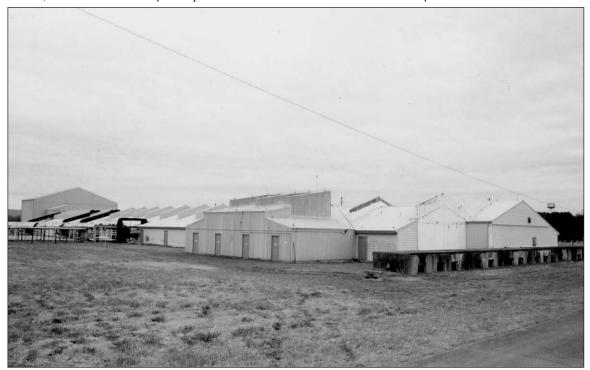
B. 1996 photograph of packing and shipping building, Building 7554, Line 3, Redstone Arsenal (Panamerican Consultants, Inc., 1998).

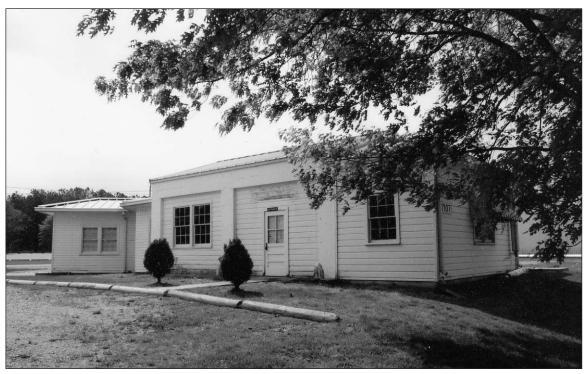
A. 1996 photograph of Building 7107, showing odd configuration due to additions, Redstone Arsenal (Panamerican Consultants, inc., 1998)

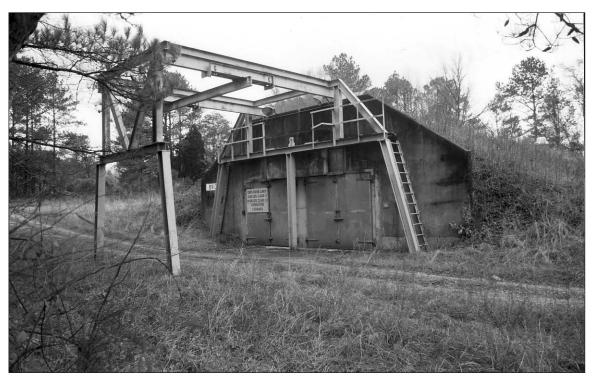
A. 1996 photograph of igloo, Building 8913, showing crane system, GCWD (Panamerican Consultants, Inc., 1998).

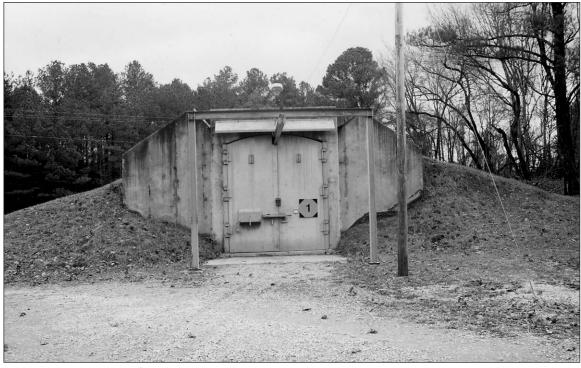
B. 1996 photograph of igloo, Building 8869, showing crane system, GCWD (Panamerican Consultants, Inc., 1998).
